Evergreen Club  
(f.k.a. Mid Rivers Yacht & Country Club)

Surface Water Management Permit No. 43-00069-S  
Permit Modification Application No. 10237-E  
issued January 7, 1988  
photos taken August 3, 2001

# **Evergreen Club**

**Surface Water Management Permit 43-00069-S  
photos taken on August 15, 2001**

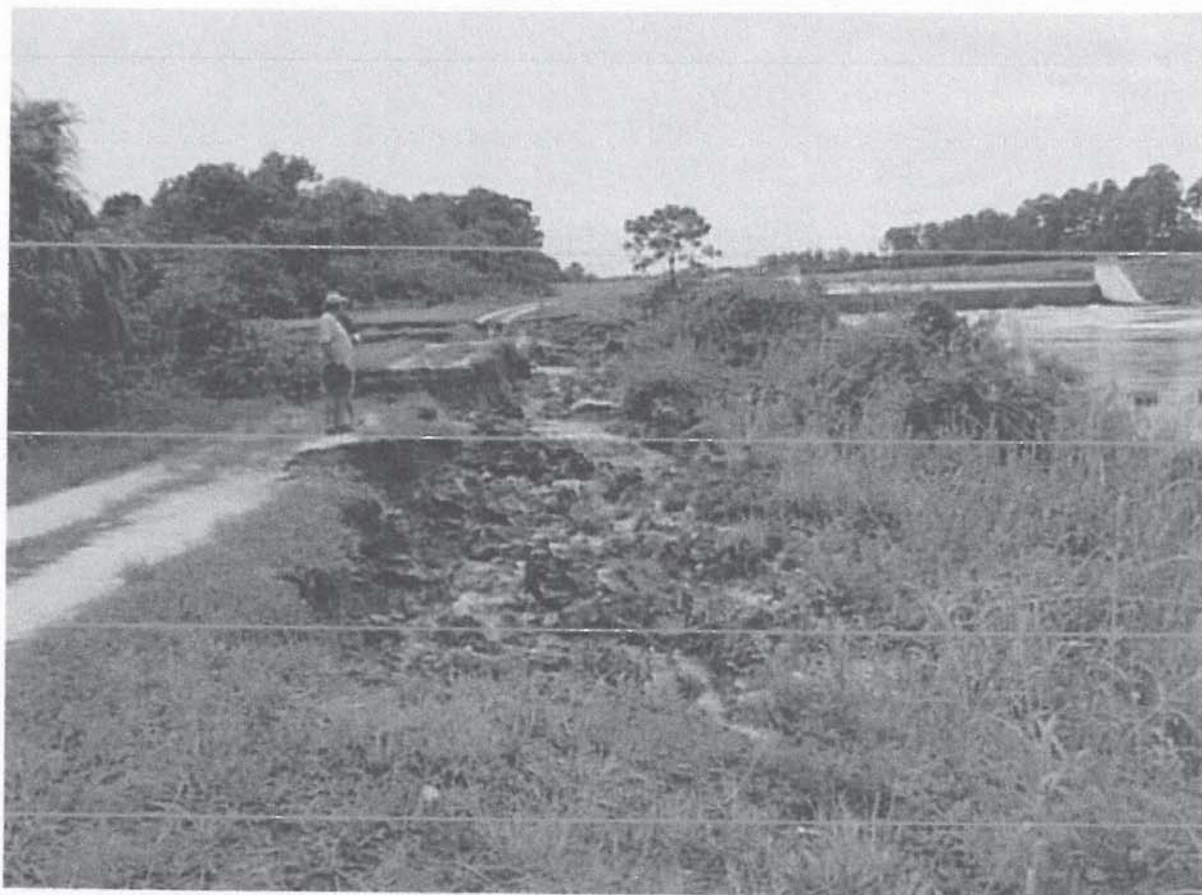
S. side C-23 8/3/01

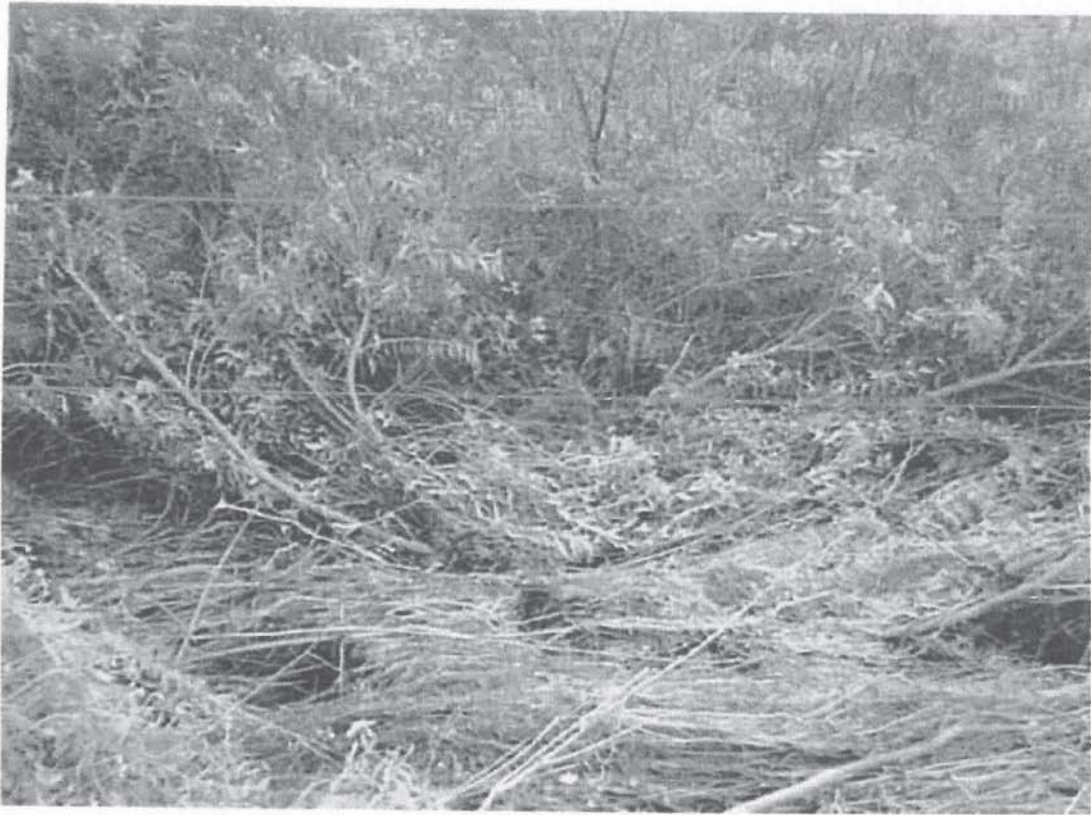
S. side of levee

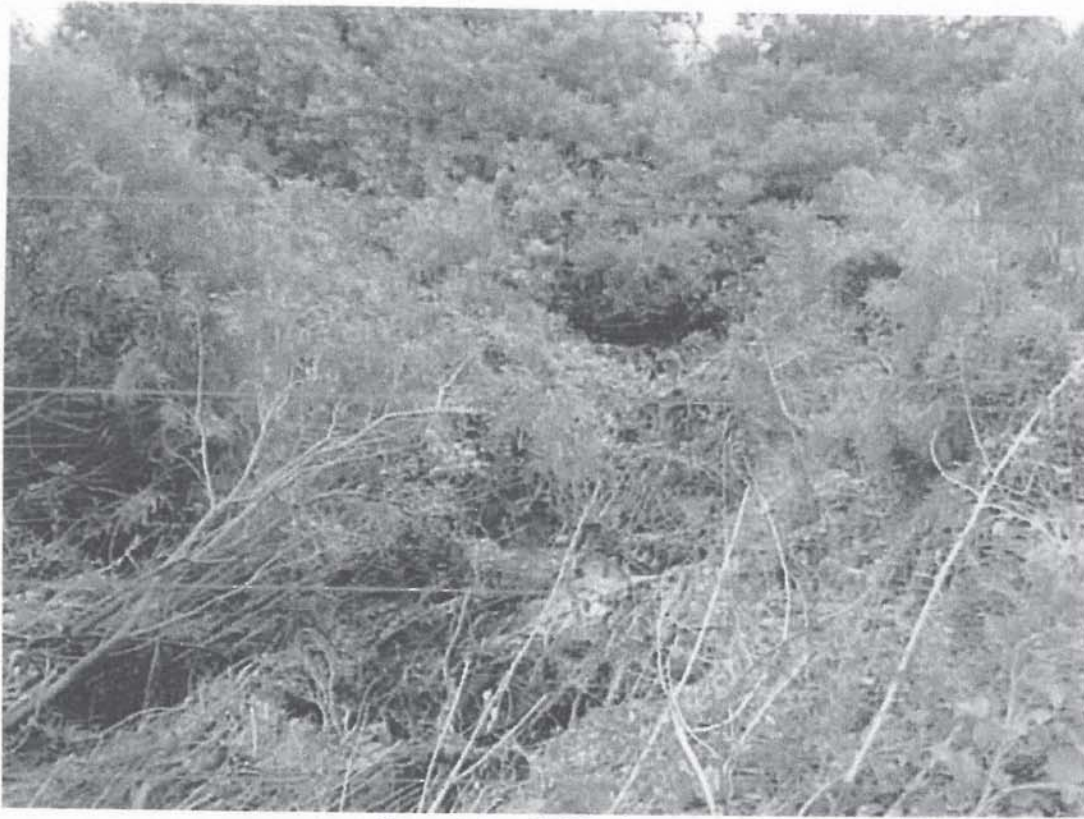
S. side C-23 levee

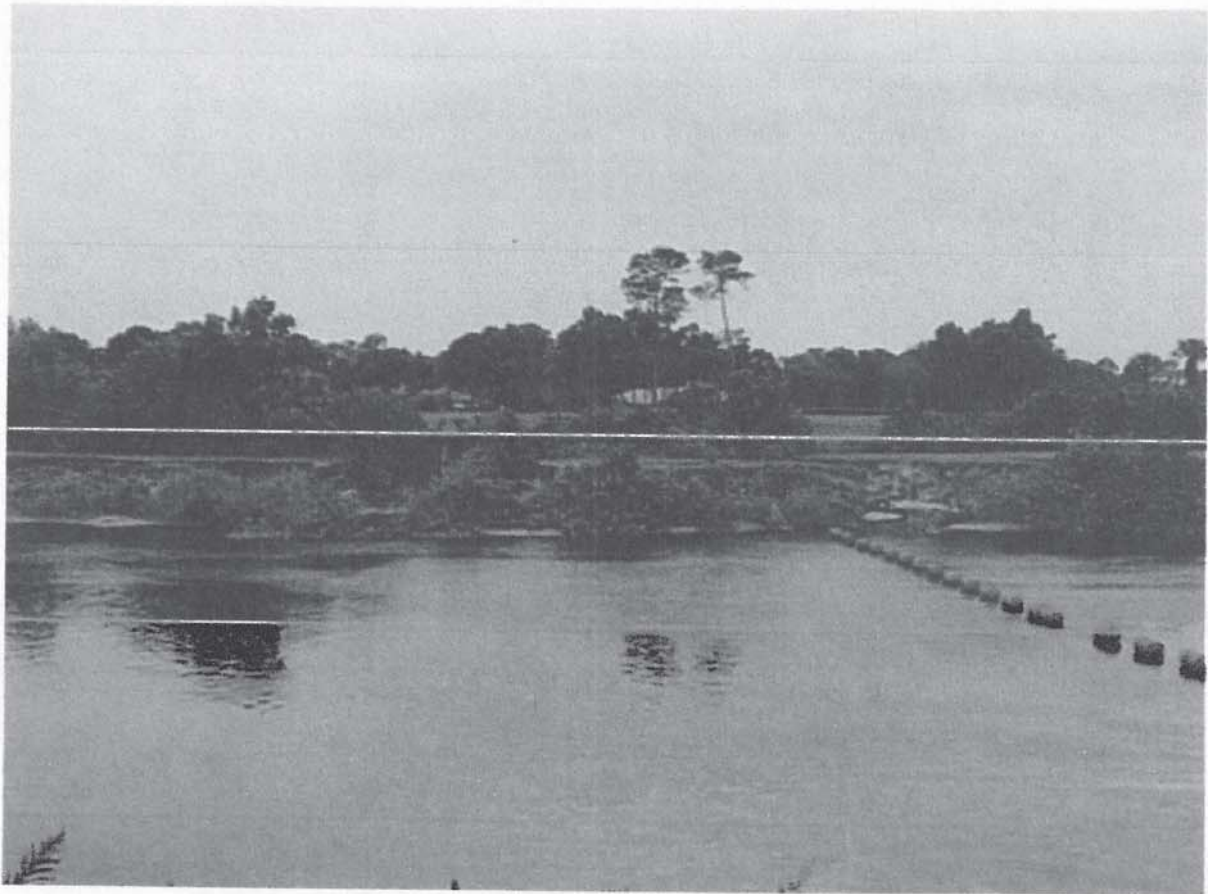
from N. side of C-23

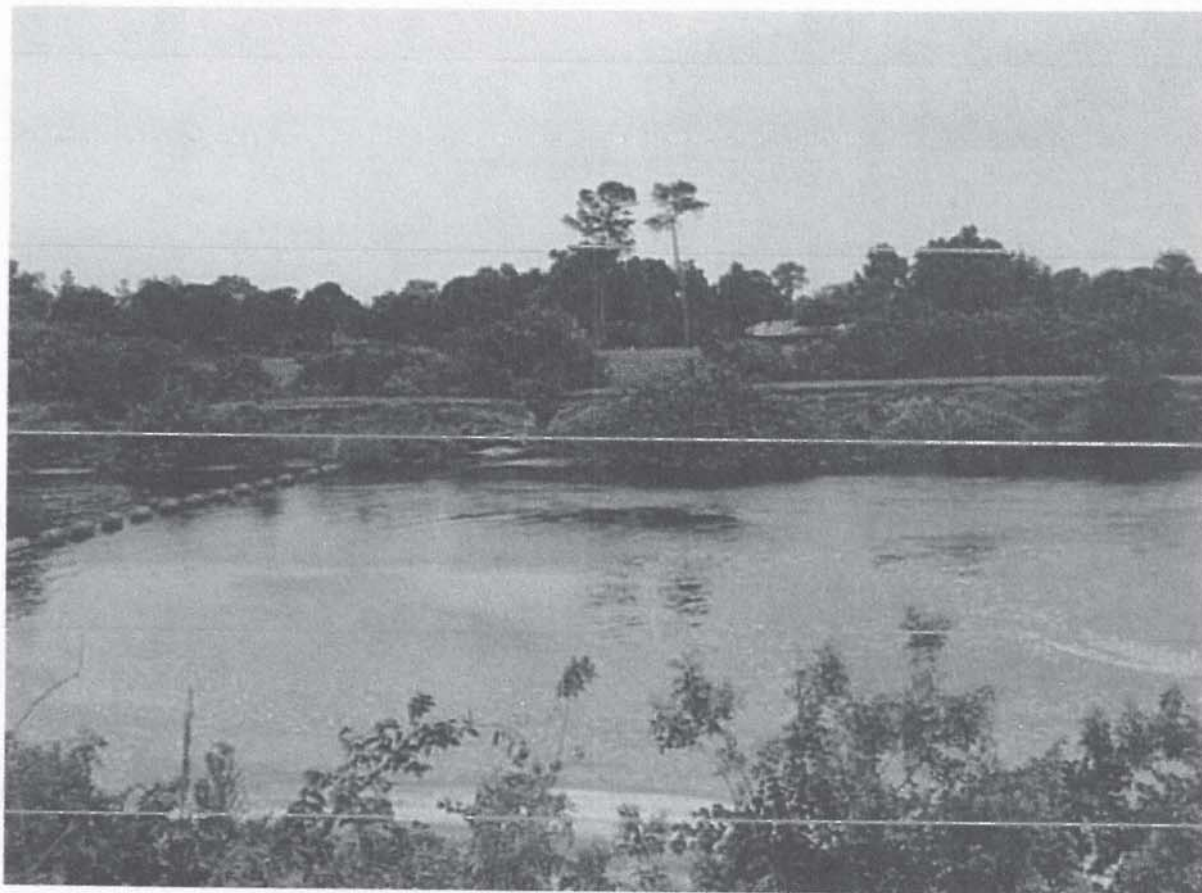
from N. side of C-23

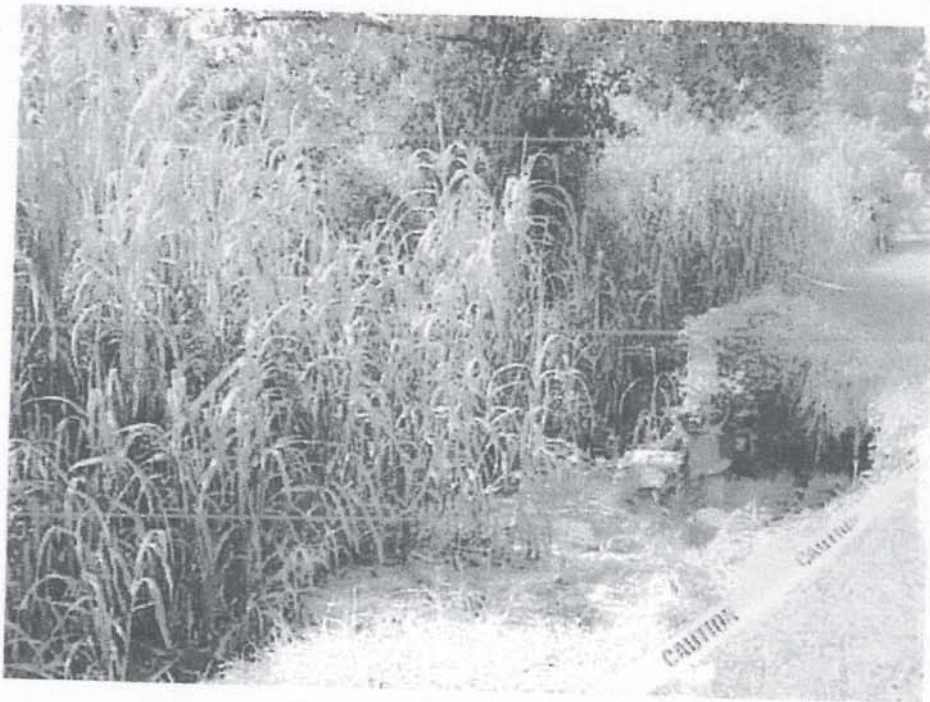
Date: 8/15/01 Time: ~ 10:15 am  
Photographer: Edward J. Maciejko  
Camera: Epson PhotoPC500, Model G640A, SN:7TN1 312916  
Section: 1 Township: 38S Range: 40E County: Martin  
Direction: S- SE, looking along E R/W of W Murphy Road  
Permit #: 43-00069-S Application #: 05137-A & 10237-E  
Project: Evergreen Club outfall culvert/headwall to Bessey Creek  
Comments: erosion on N side, vegetation in Creek, ~ 36" dia.  
Remarks: Camera was working properly. Picture No. 1

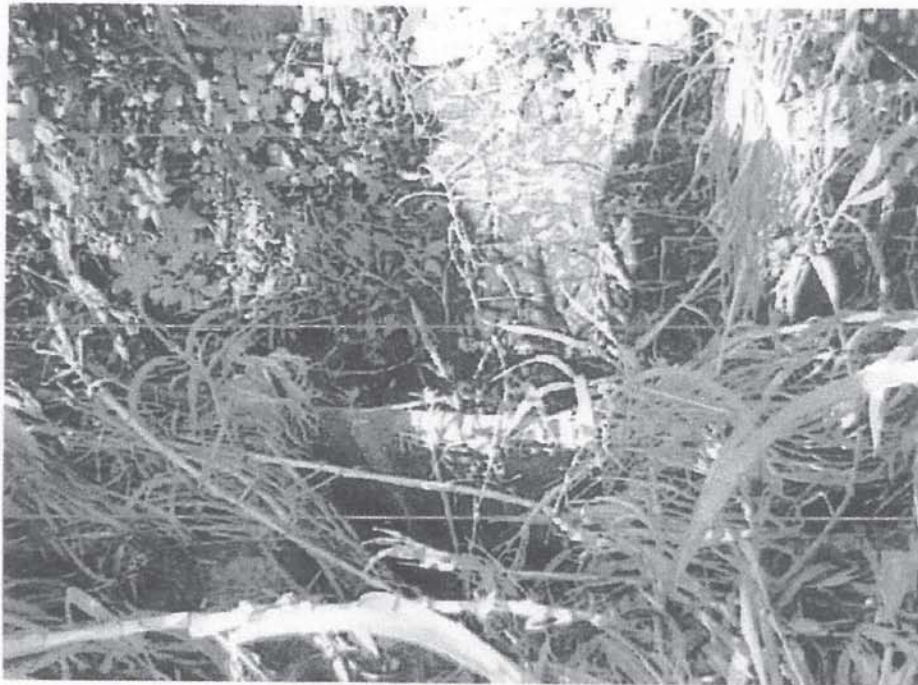
Date: 8/15/01 Time: 10:20 am  
Photographer: Edward J. Maciejko  
Camera: Epson PhotoPC500, Model G640A, SN:7TN1 312916  
Section: 1 Township: 38S Range: 40E County: Martin  
Direction: W, looking from West Murphy Road R/W  
Permit #: 43-00069-S Application #: 05137-A & 10237-E  
Project: Evergreen Club Control Structure No. 2 to Bessey Creek  
Comments: 48" riser on 36" CMP, boards in, bleeder submerged  
Remarks: Camera was working properly. Picture No. 2

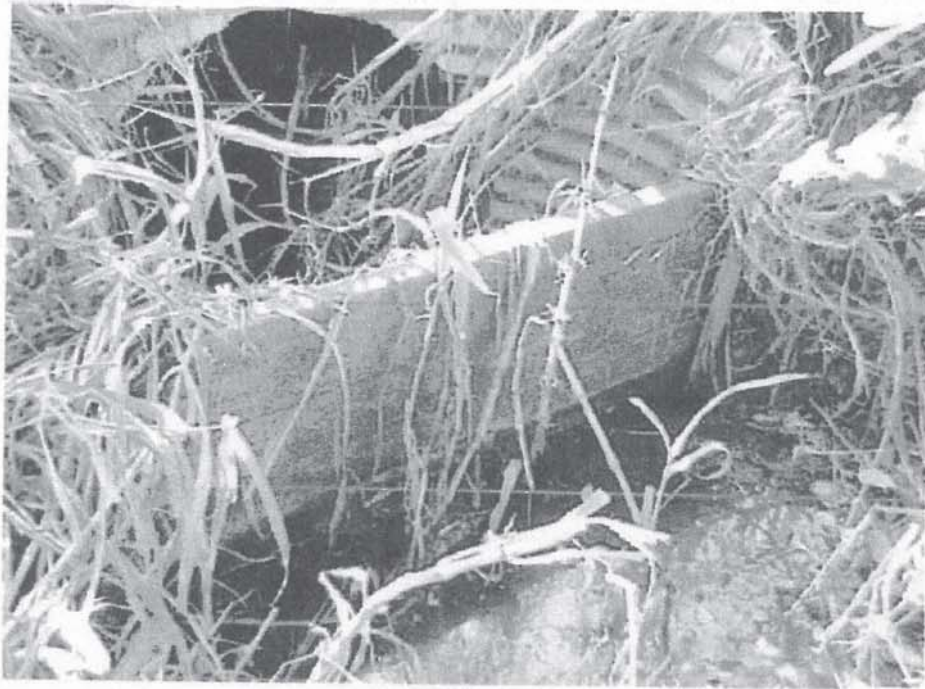
Date: 8/15/01 Time: 10:20 am  
Photographer: Edward J. Maciejko  
Camera: Epson PhotoPC500, Model G640A, SN:7TN1 312916  
Section: 1 Township: 38S Range: 40E County: Martin  
Direction: E-SE, looking from swale along W side of Murphy Rd  
Permit #: 43-00069-S Application #: 05137-A & 10237-E  
Project: Evergreen Club Control Structure No. 2 to Bessey Creek  
Comments: 48" riser on 36" CMP, boards in, bleeder submerged  
Remarks: Camera was working properly. Picture No. 3

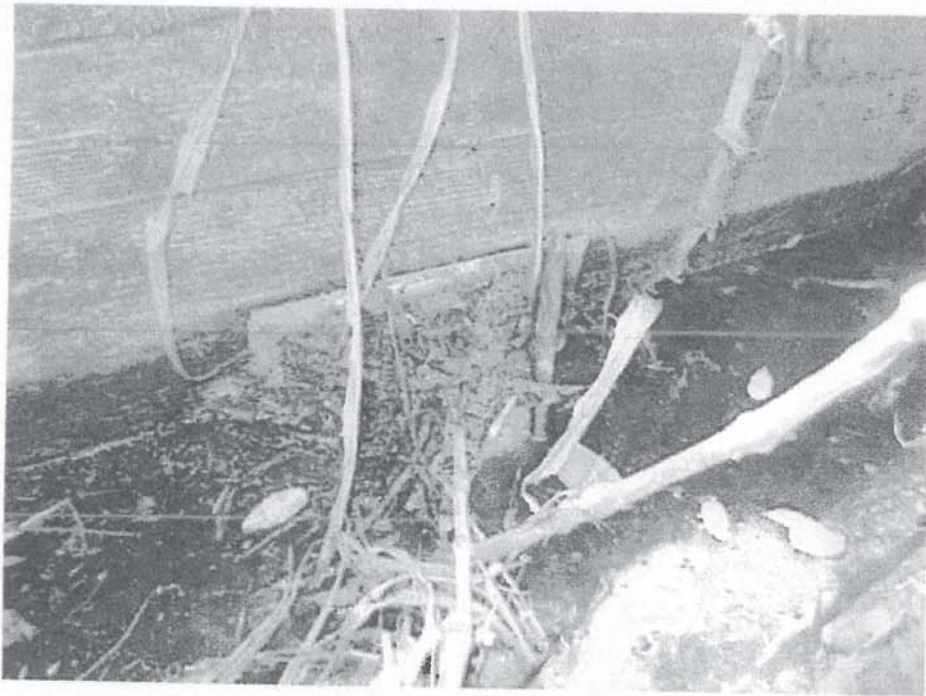
Date: 8/15/01 Time: 10:25 am  
Photographer: Edward J. Maciejko  
Camera: Epson PhotoPC500, Model G640A, SN:7TN1 312916  
Section: 1 Township: 38S Range: 40E County: Martin  
Direction: E-SE, looking from swale along W side of Murphy Rd  
Permit #: 43-00069-S Application #: 05137-A & 10237-E  
Project: Evergreen Club Control Structure No. 2 to Bessey Creek  
Comments: vegetation/debris on wire mesh baffle of bleeder orifice  
Remarks: Camera was working properly. Picture No. 4

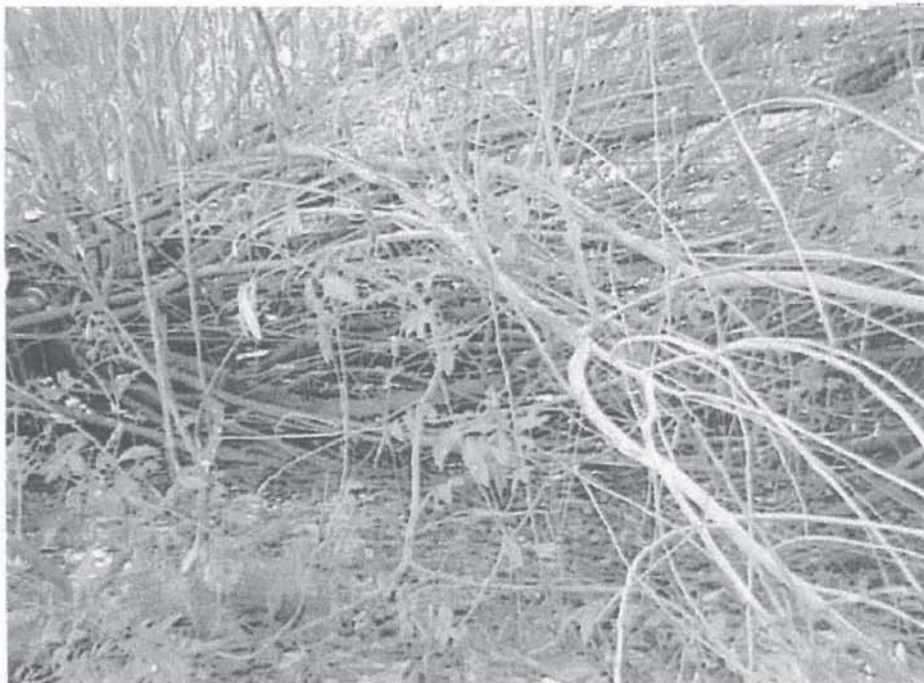
Date: 8/15/01 Time: ~ 10:30 am  
Photographer: Edward J. Maciejko  
Camera: Epson PhotoPC500, Model G640A, SN:7TN1 312916  
Section: 1 Township: 38S Range: 40E County: Martin  
Direction: looking at swale along W side of Murphy Road  
Permit #: 43-00069-S Application #: 05137-A & 10237-E  
Project: Evergreen Club swale area at Control Structure No. 2  
Comments: sedimentation and vegetative overgrowth of swale area  
Remarks: Camera was working properly. Picture No. 5

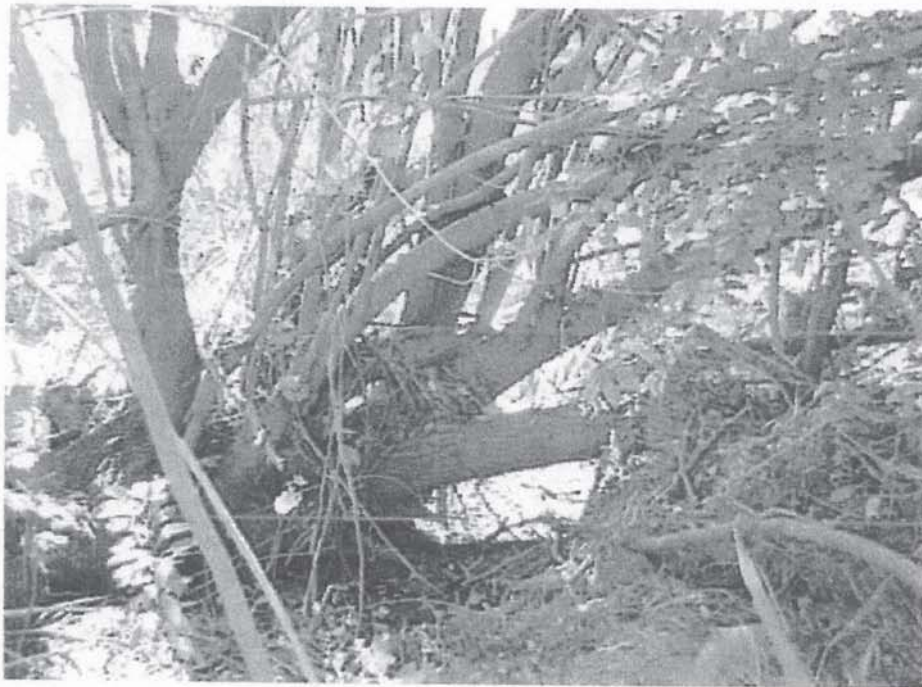
Date: 8/15/01 Time: 10:30 am  
Photographer: Edward J. Maciejko  
Camera: Epson PhotoPC500, Model G640A, SN:7TN1 312916  
Section: 1 Township: 38S Range: 40E County: Martin  
Direction: E, looking at swale and riser from golf course side  
Permit #: 43-00069-S Application #: 05137-A & 10237-E  
Project: Evergreen Club backside of swale at Structure No. 2  
Comments: vegetative overgrowth, culvert barely visible in center  
Remarks: Camera was working properly. Picture No. 6

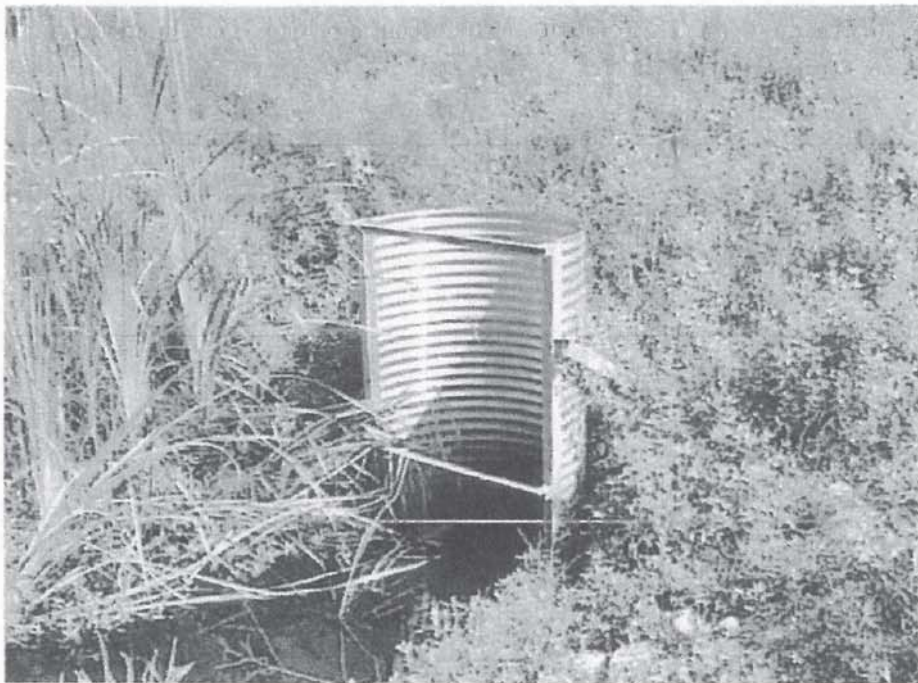
Date: 8/15/01 Time: 10:45 am  
Photographer: Edward J. Maciejko  
Camera: Epson PhotoPC500, Model G640A, SN:7TN1 312916  
Section: 1 Township: 38S Range: 40E County: Martin  
Direction: NW, looking at backside (south side) of C-23 R/W  
Permit #: 43-00069-S Application #: 05137-A & 10237-E  
Project: Evergreen Club, looking at Control Structure No. 1  
Comments: no boards in 48" flash board riser, water flowing out  
Remarks: Camera was working properly. Picture No. 7

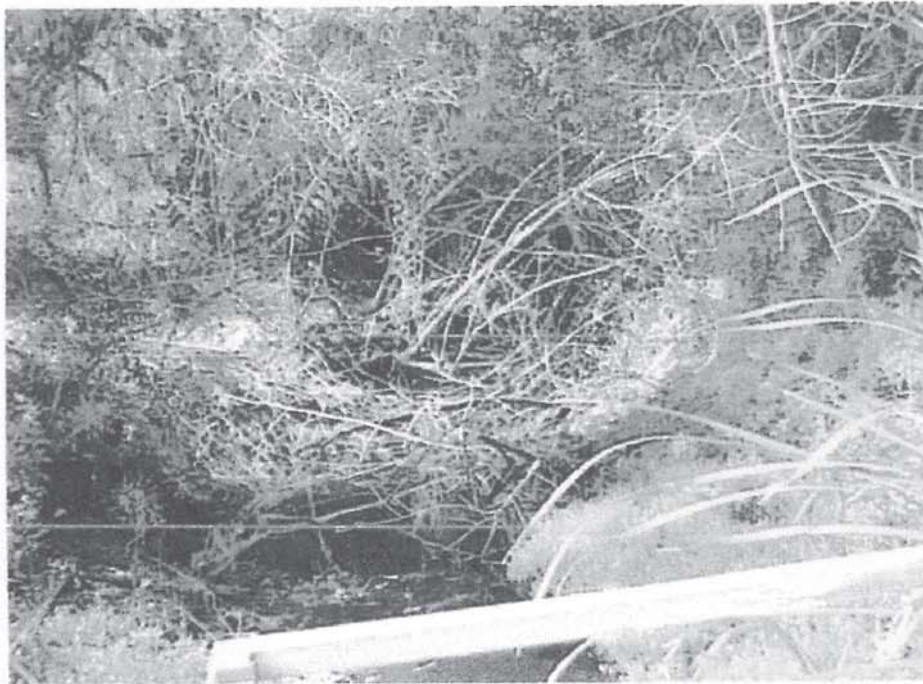
Date: 8/15/01 Time: 10:50 am  
Photographer: Edward J. Maciejko  
Camera: Epson PhotoPC500, Model G640A, SN:7TN1 312916  
Section: 1 Township: 38S Range: 40E County: Martin  
Direction: S, looking from backside of Structure No. 1 on C-23  
Permit #: 43-00069-S Application #: 05137-A & 10237-E  
Project: Evergreen Club, looking at swale/slough conveyance  
Comments: vegetative overgrowth of swale/slough to structure  
Remarks: Camera was working properly. Picture No. 8

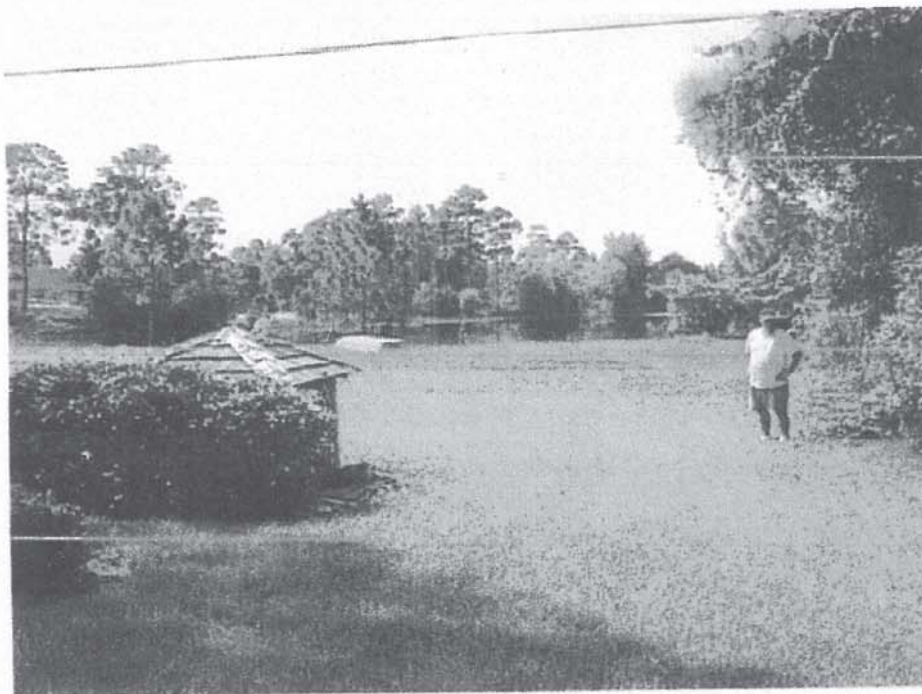
Date: 8/15/01 Time: 11 - 11:30 am  
Photographer: Edward J. Maciejko  
Camera: Epson PhotoPC500, Model G640A, SN:7TN1 312916  
Section: 1 Township: 38S Range: 40E County: Martin  
Direction: S - SE, looking along southern property line  
Permit #: 43-00069-S Application #: 05137-A & 10237-E  
Project: Evergreen Club, southern property line of residential lot  
Comments: no significant berm, inflow area from Hidden Bay/lake  
Remarks: Camera was working properly. Picture No. 10

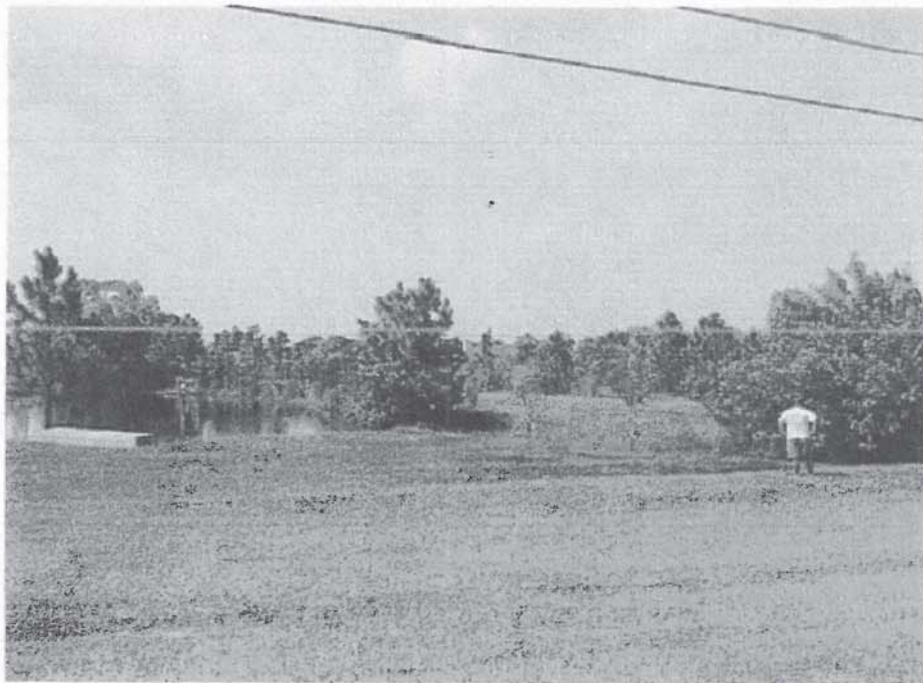
Date: 8/15/01 Time: ~ 11 - 11:30 am  
Photographer: Edward J. Maciejko  
Camera: Epson PhotoPC500, Model G640A, SN:7TN1 312916  
Section: 1 Township: 38S Range: 40E County: Martin  
Direction: S - SW, looking along southern property line  
Permit #: 43-00069-S Application #: 05137-A & 10237-E  
Project: Evergreen Club, southern property line of residential lot  
Comments: area of off-site inflows from Hidden Bay/Canoe Creek  
Remarks: Camera was working properly. Picture No. 11

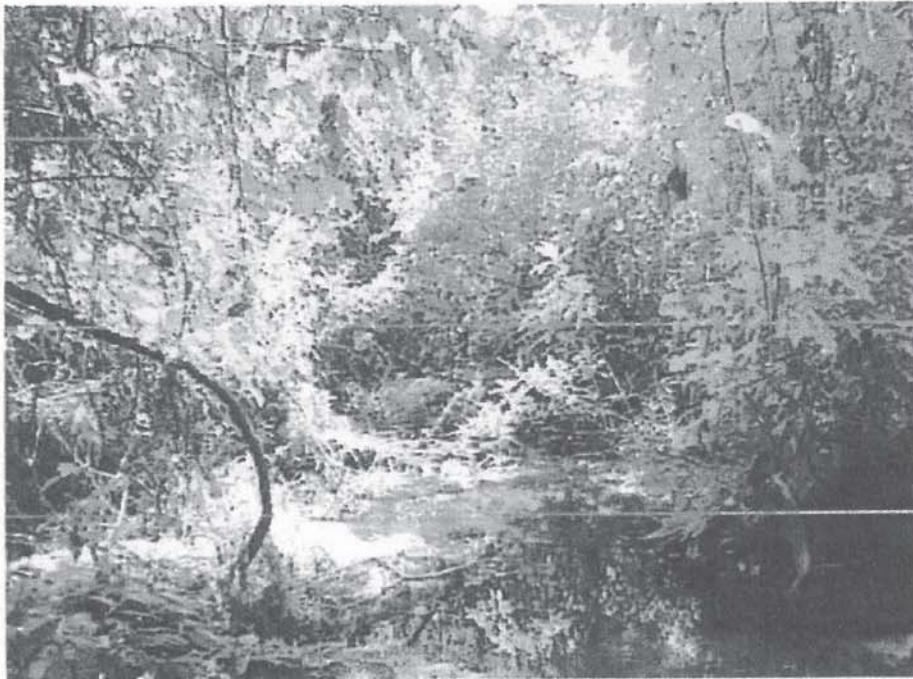
Date: 8/15/01 Time: ~ 11 am -12 pm  
Photographer: Edward J. Maciejko  
Camera: Epson PhotoPC500, Model G640A, SN:7TN1 312916  
Section: 2 Township: 38S Range: 40E County: Martin  
Direction: ~ E, looking at internal swale / ditch  
Permit #: 43-00069-S Application #: 05137-A & 10237-E  
Project: Evergreen Club swale / ditch  
Comments: sedimentation and vegetative overgrowth of area  
Remarks: Camera was working properly. Picture No.12

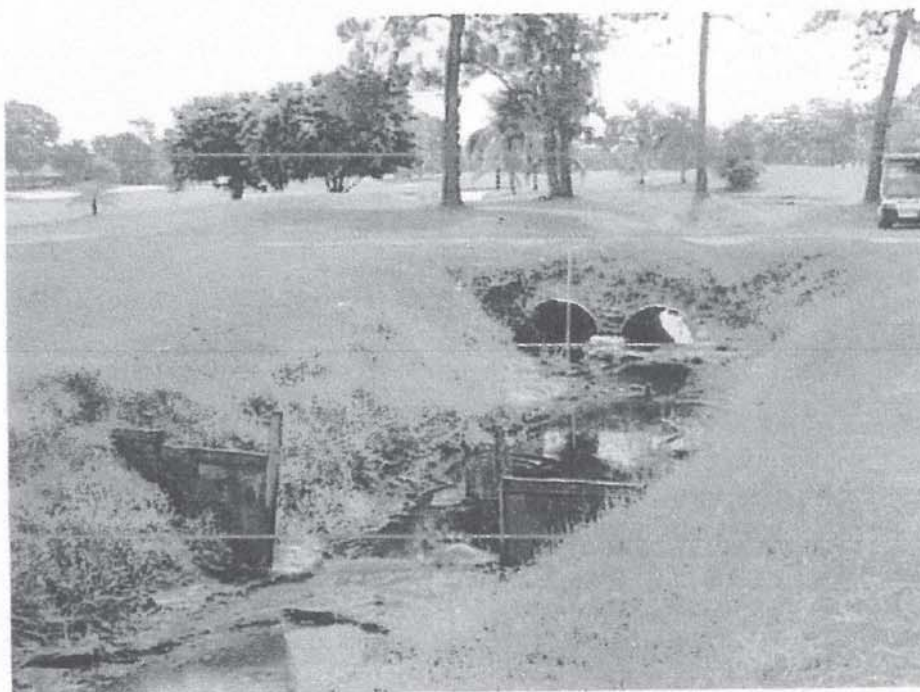
Date: 8/15/01 Time: ~ 11 am - 12 pm  
Photographer: Edward J. Maciejko  
Camera: Epson PhotoPC500, Model G640A, SN:7TN1 312916  
Section: 2 Township: 38S Range: 40E County: Martin  
Direction: E, looking along ditch  
Permit #: 43-00069-S Application #: 05137-A & 10237-E  
Project: Evergreen Club, previous weir in foreground  
Comments: culverts used to control water elevation  
Remarks: Camera was working properly. Picture No. 13

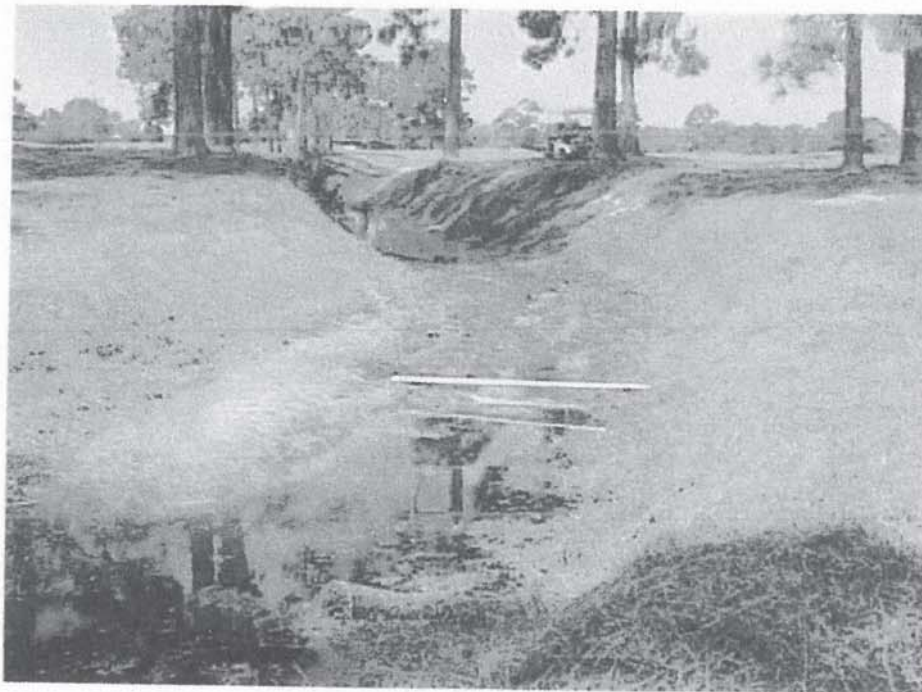
Date: 8/15/01 Time: ~ 11 am - 12 pm  
Photographer: Edward J. Maciejko  
Camera: Epson PhotoPC500, Model G640A, SN:7TN1 312916  
Section: 2 Township: 38S Range: 40E County: Martin  
Direction: E, looking along ditch  
Permit #: 43-00069-S Application #: 05137-A & 10237-E  
Project: Evergreen Club, internal ditch needs cleaning of silt  
Comments: my surveying rod laying along irrigation pipe  
Remarks: Camera was working properly. Picture No. 14

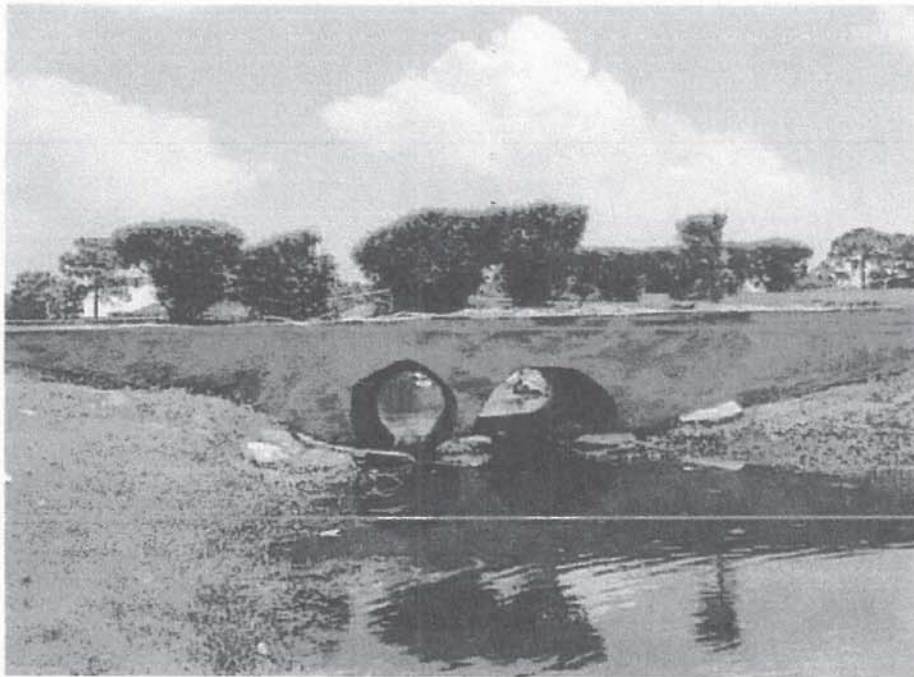
Date: 8/15/01 Time: 11:30 am - 12:30 pm  
Photographer: Edward J. Maciejko  
Camera: Epson PhotoPC500, Model G640A, SN:7TN1 312916  
Section: 2 Township: 38S Range: 40E County: Martin  
Direction: NE, looking along ditch  
Permit #: 43-00069-S Application #: 05137-A & 10237-E  
Project: Evergreen Club, internal ditch needs cleaning of silt  
Comments: rocks in front of left culvert, and concrete in other  
Remarks: Camera was working properly. Picture No. 15

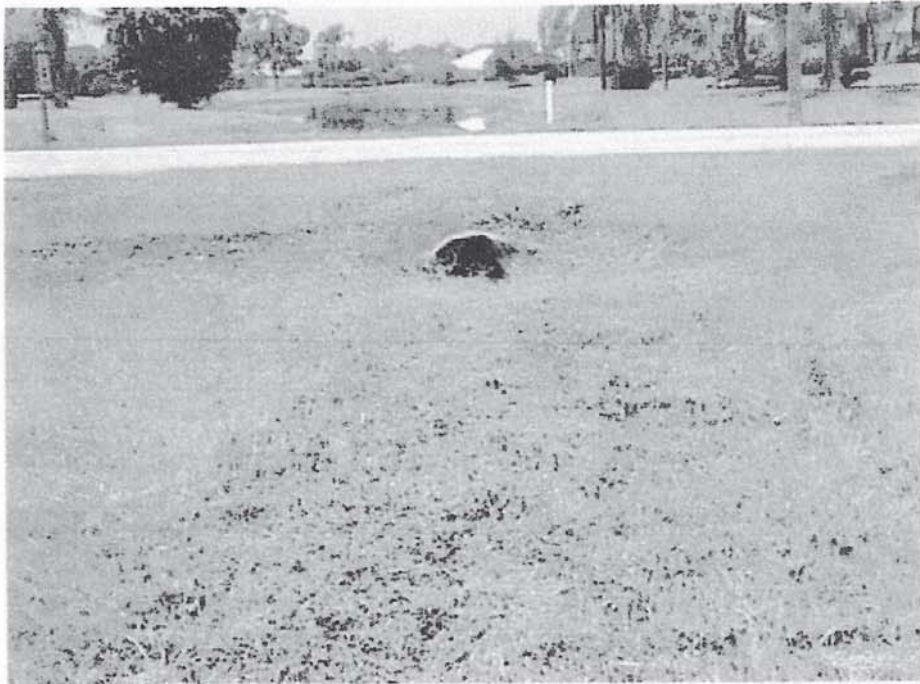
Date: 8/15/01 Time: ~ 12:30 - 1:30 pm  
Photographer: Edward J. Maciejko  
Camera: Epson PhotoPC500, Model G640A, SN:7TN1 312916  
Section: 3 Township: 38S Range: 40E County: Martin  
Direction: W, looking at culvert/headwall to swale connection  
Permit #: 43-00069-S Application #: 05137-A & 10237-E  
Project: Evergreen Club, internal swale needs cleaning  
Comments: sediment and vegetation causing blockage in swale  
Remarks: Camera was working properly. Picture No. 16

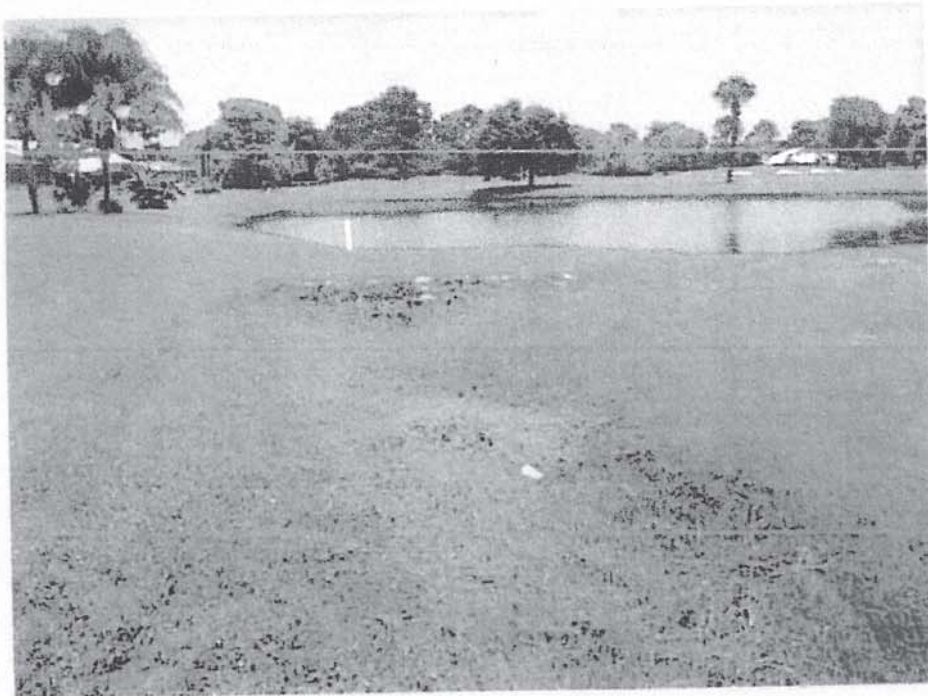
Date: 8/15/01 Time: ~ 12:30 - 1:30 pm  
Photographer: Edward J. Maciejko  
Camera: Epson PhotoPC500, Model G640A, SN:7TN1 312916  
Section: 3 Township: 38S Range: 40E County: Martin  
Direction: W, looking at culvert from lake to swale under road  
Permit #: 43-00069-S Application #: 05137-A & 10237-E  
Project: Evergreen Club, internal swale needs cleaning  
Comments: sediment and vegetation causing blockage in swale  
Remarks: Camera was working properly. Picture No. 17

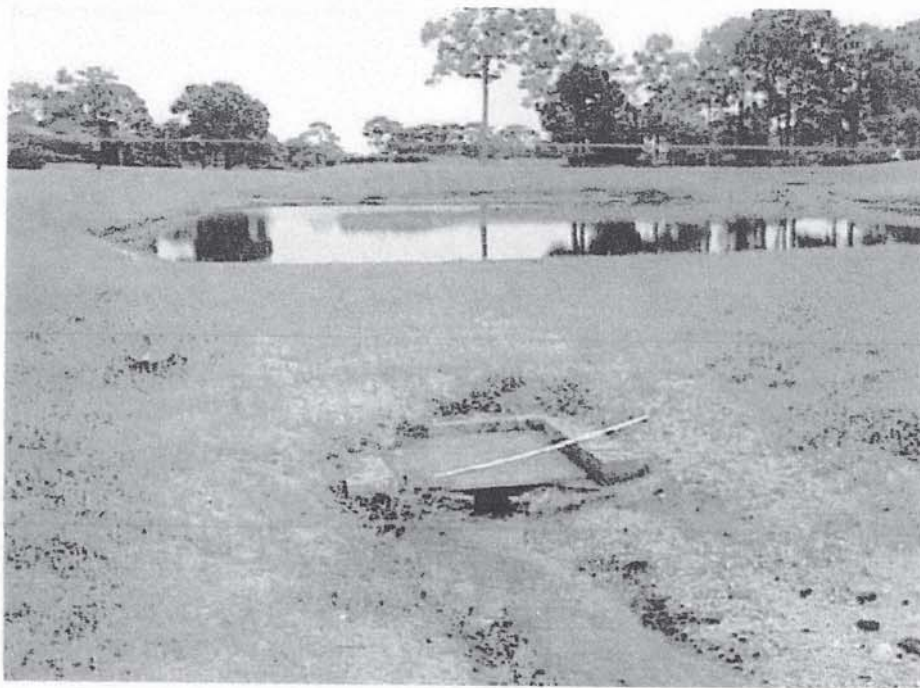
Date: 8/15/01 Time: ~ 12:30 - 1:30 pm  
Photographer: Edward J. Maciejko  
Camera: Epson PhotoPC500, Model G640A, SN:7TN1 312916  
Section: 2 Township: 38S Range: 40E County: Martin  
Direction: E, looking at riser/culvert from swale lake  
Permit #: 43-00069-S Application #: 05137-A & 10237-E  
Project: Evergreen Club, ~ 2' plastic riser w/ square notch  
Comments: sediment/small gravel in swale could cause blockage  
Remarks: Camera was working properly. Picture No. 18

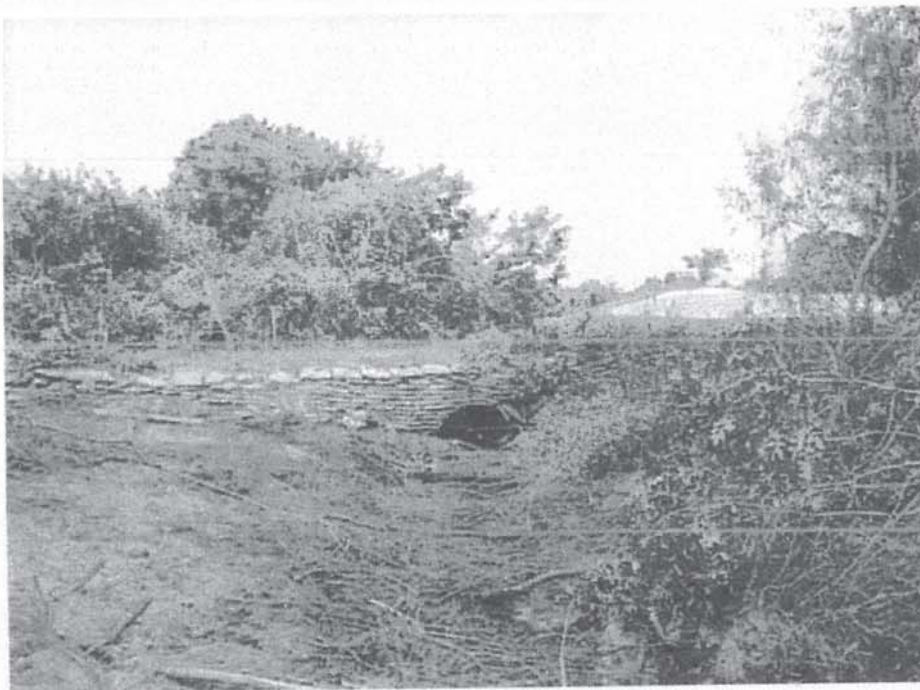
Date: 8/15/01 Time: ~ 2:00 - 2:30 pm  
Photographer: Edward J. Maciejko  
Camera: Epson PhotoPC500, Model G640A, SN:7TN1 312916  
Section: 1 Township: 38S Range: 40E County: Martin  
Direction: E, looking at golf cart crossing along S side of C-23  
Permit #: 43-00069-S Application #: 05137-A & 10237-E  
Project: Evergreen Club, north perimeter W-E swale crossing  
Comments: cleaned up swale between Structures No. 1 & No. 2  
Remarks: Camera was working properly. Picture No. 19

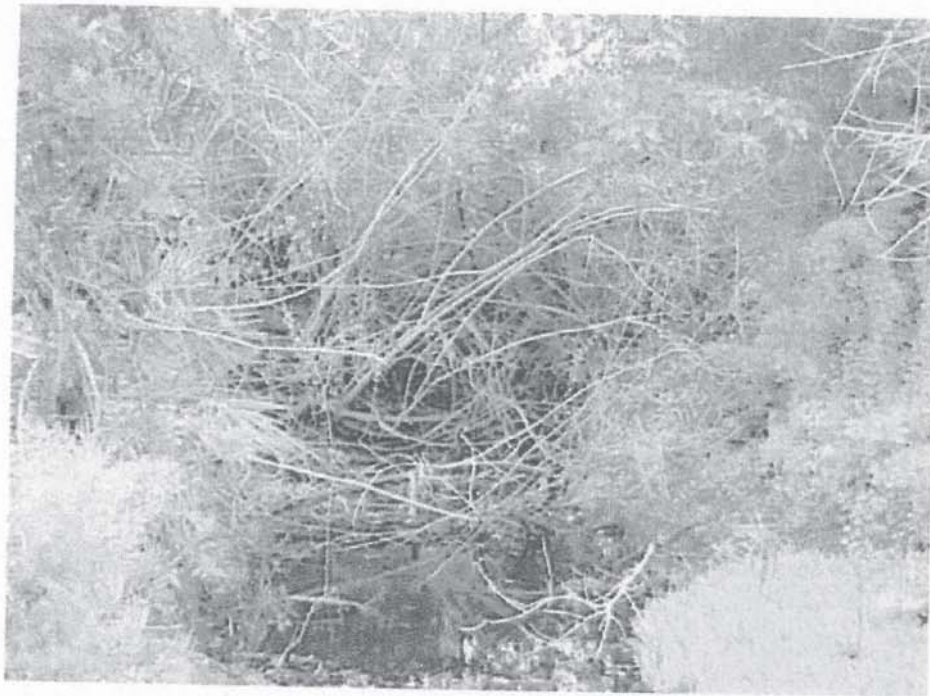
Date: 8/15/01 Time: ~ 2:30 pm  
Photographer: Edward J. Maciejko  
Camera: Epson PhotoPC500, Model G640A, SN:7TN1 312916  
Section: 1 Township: 38S Range: 40E County: Martin  
Direction: S, looking upstream at conveyance way to structure  
Permit #: 43-00069-S Application #: 05137-A & 10237-E  
Project: Evergreen Club, swale from slough to Control Str. No.1  
Comments: swale / slough overgrown with vegetation upstream  
Remarks: Camera was working properly. Picture No. 20

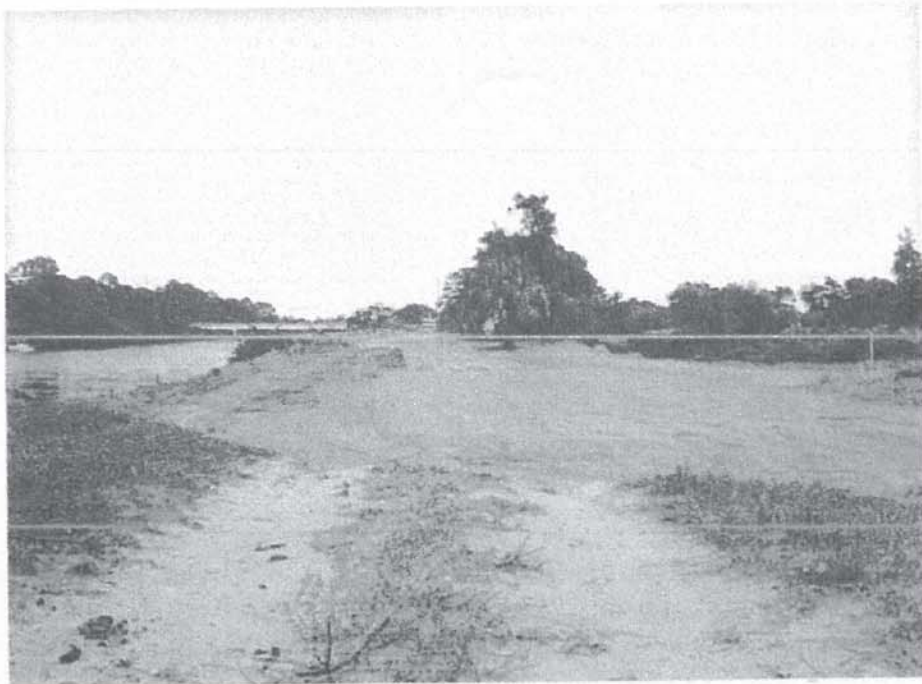
Date: 8/15/01 Time: ~ 2:30 pm  
Photographer: Edward J. Maciejko  
Camera: Epson PhotoPC500, Model G640A, SN:7TN1 312916  
Section: 1 Township: 38S Range: 40E County: Martin  
Direction: E, looking along south bank of C-23 Canal  
Permit #: 43-00069-S Application #: 05137-A & 10237-E  
Project: Evergreen Club, restoration of C-23 levee  
Comments: mature cabbage palm appears lower than rest of levee  
Remarks: Camera was working properly. Picture No. 21

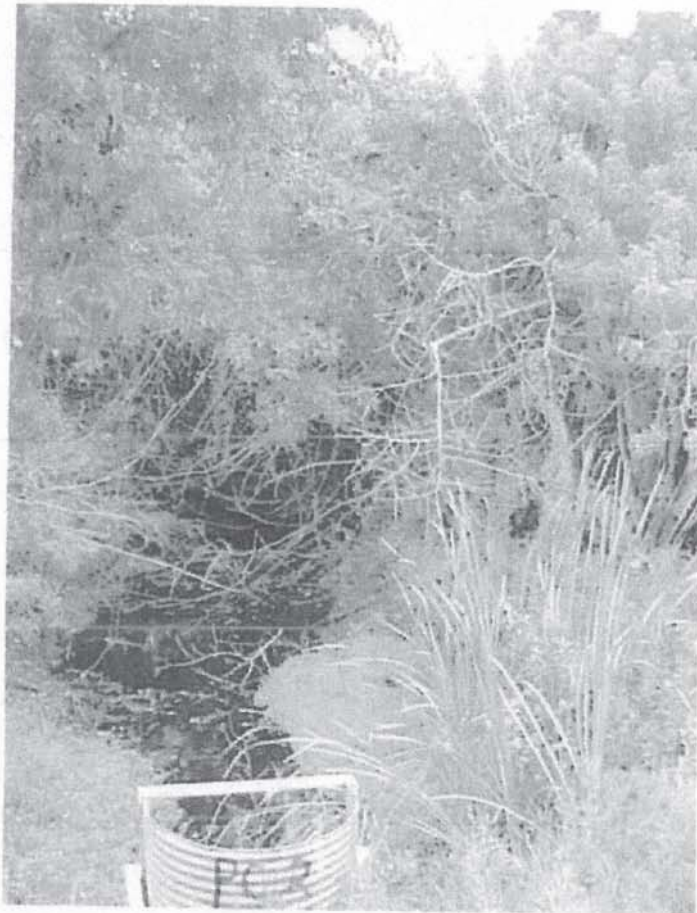
Date: 8/15/01 Time: 3:00 pm  
Photographer: Edward J. Maciejko  
Camera: Epson PhotoPC500, Model G640A, SN:7TN1 312916  
Section: 1 Township: 38S Range: 40E County: Martin  
Direction: S, looking at swale / slough leading to PC-2  
Permit #: 43-00089-S Application #: 05137-A & 10237-E  
Project: Evergreen Club, inflow to Control Structure No. 1  
Comments: swale / slough overgrown with vegetation  
Remarks: Camera was working properly. Picture No. 22

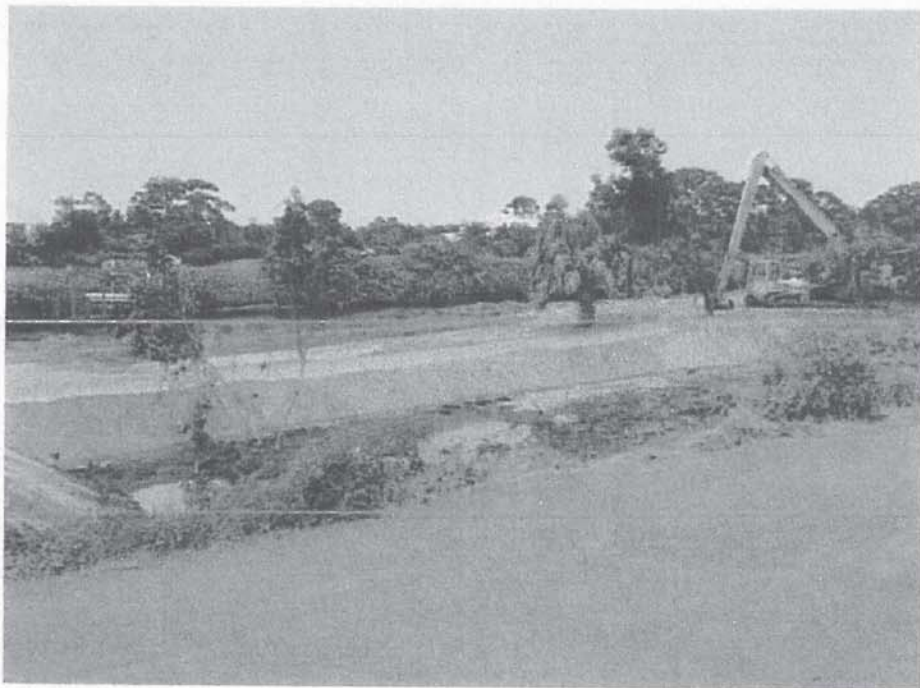
Date: 8/15/01 Time: 3:00 pm  
Photographer: Edward J. Maciejko  
Camera: Epson PhotoPC500, Model G640A, SN:7TN1 312916  
Section: 1 Township: 38S Range: 40E County: Martin  
Direction: NE, from golf course looking at C-23 levee  
Permit #: 43-00069-S Application #: 05137-A & 10237-E  
Project: Evergreen Club's W - E ditch cleaned in foreground  
Comments: appears to be low spot in levee, note cabbage palm  
Remarks: Camera was working properly. Picture No. 23

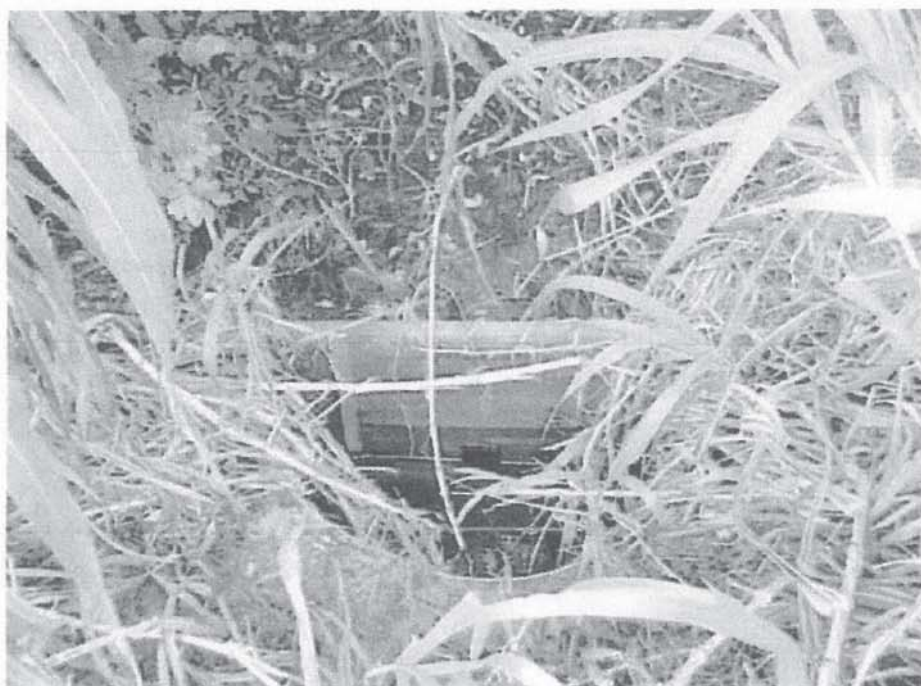
Date: 8/15/01 Time: ~ 3:15 pm  
Photographer: Edward J. Maciejko  
Camera: Epson PhotoPC500, Model G640A, SN:7TN1 312916  
Section: 1 Township: 38S Range: 40E County: Martin  
Direction: W, looking from West Murphy Road R/W  
Permit #: 43-00069-S Application #: 05137-A & 10237-E  
Project: Evergreen Club Control Structure No. 2 to Bessey Creek  
Comments: square bleeder orifice visible  
Remarks: Camera was working properly. Picture No. 24
