Evergreen Club  
(f.k.a. Mid Rivers Yacht & Country Club)

Surface Water Management Permit No. 43-00069-S  
Permit Modification Application No. 10237-E  
issued January 7, 1988  
photos taken August 3, 2001

# **Evergreen Club**

**Surface Water Management Permit 43-00069-S  
photos taken on August 15, 2001**

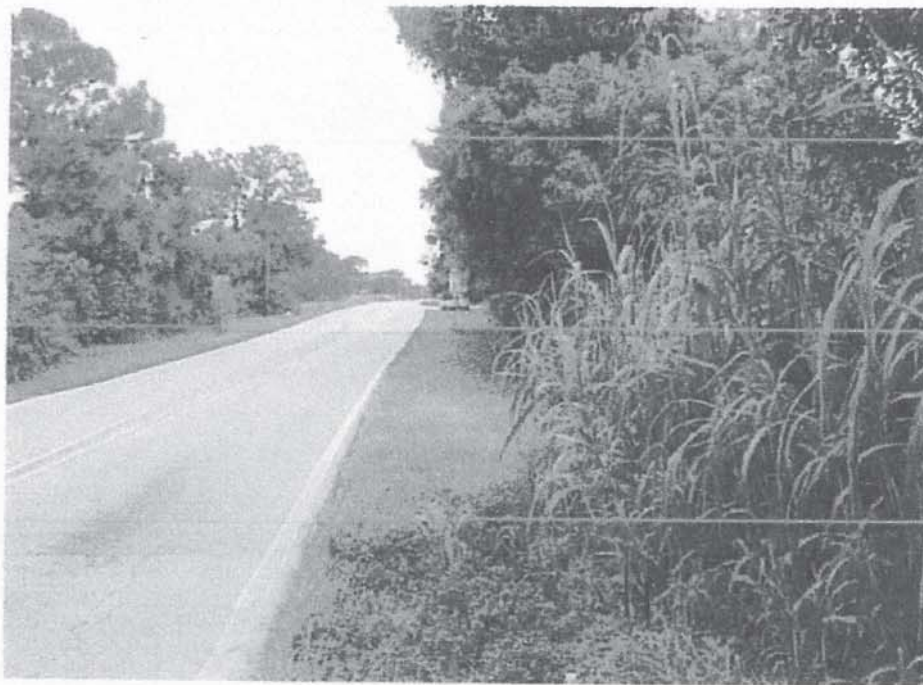
Date: 8/15/01 Time: 3:20 pm  
Photographer: Edward J. Maciejko  
Camera: Epson PhotoPC500, Model G640A, SN:7TN1 312916  
Section: 1 Township: 38S Range: 40E County: Martin  
Direction: S, looking at West Murphy Road  
Permit #: 43-00069-S Application #: 05137-A & 10237-E  
Project: Evergreen Club / Murphy roadside swale on right side  
Comments: appears street stormwater runoff could flow into system  
Remarks: Camera was working properly. Picture No. 25

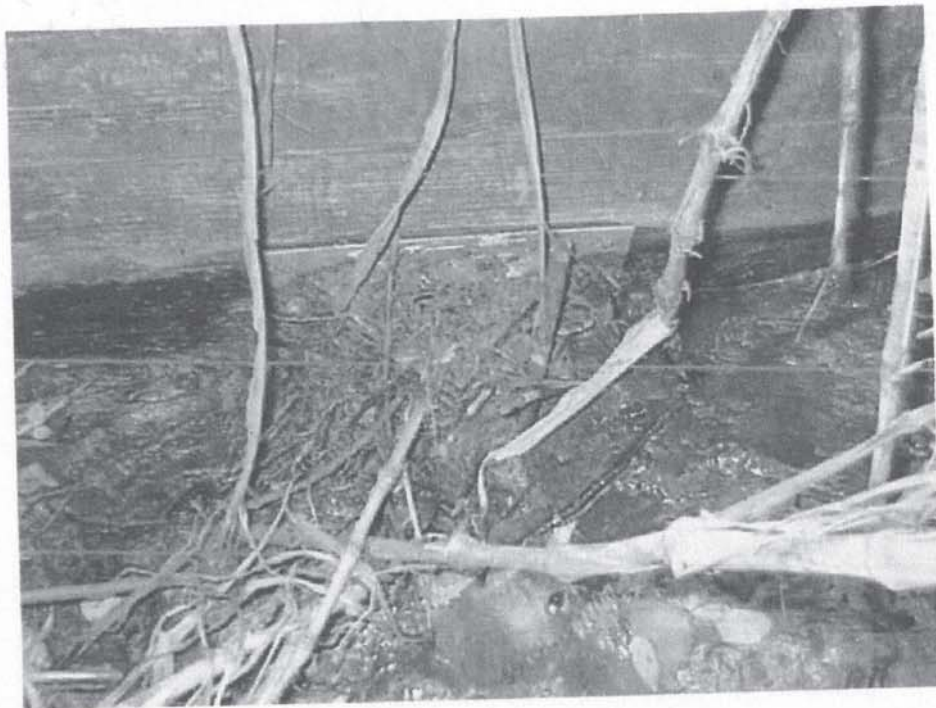
Date: 8/15/01 Time: 3:30 pm  
Photographer: Edward J. Maciejko  
Camera: Epson PhotoPC500, Model G640A, SN:7TN1 312916  
Section: 1 Township: 38S Range: 40E County: Martin  
Direction: E-SE, looking from swale along W side of Murphy Rd  
Permit #: 43-00069-S Application #: 05137-A & 10237-E  
Project: Evergreen Club Control Structure No. 2 to Bessey Creek  
Comments: vegetation/debris on wire mesh baffle of bleeder orifice  
Remarks: Camera was working properly. Picture No. 27
