SWALE 24, 4005 SW BIMINI TR. SOUTH

Bermuda Way Storm System

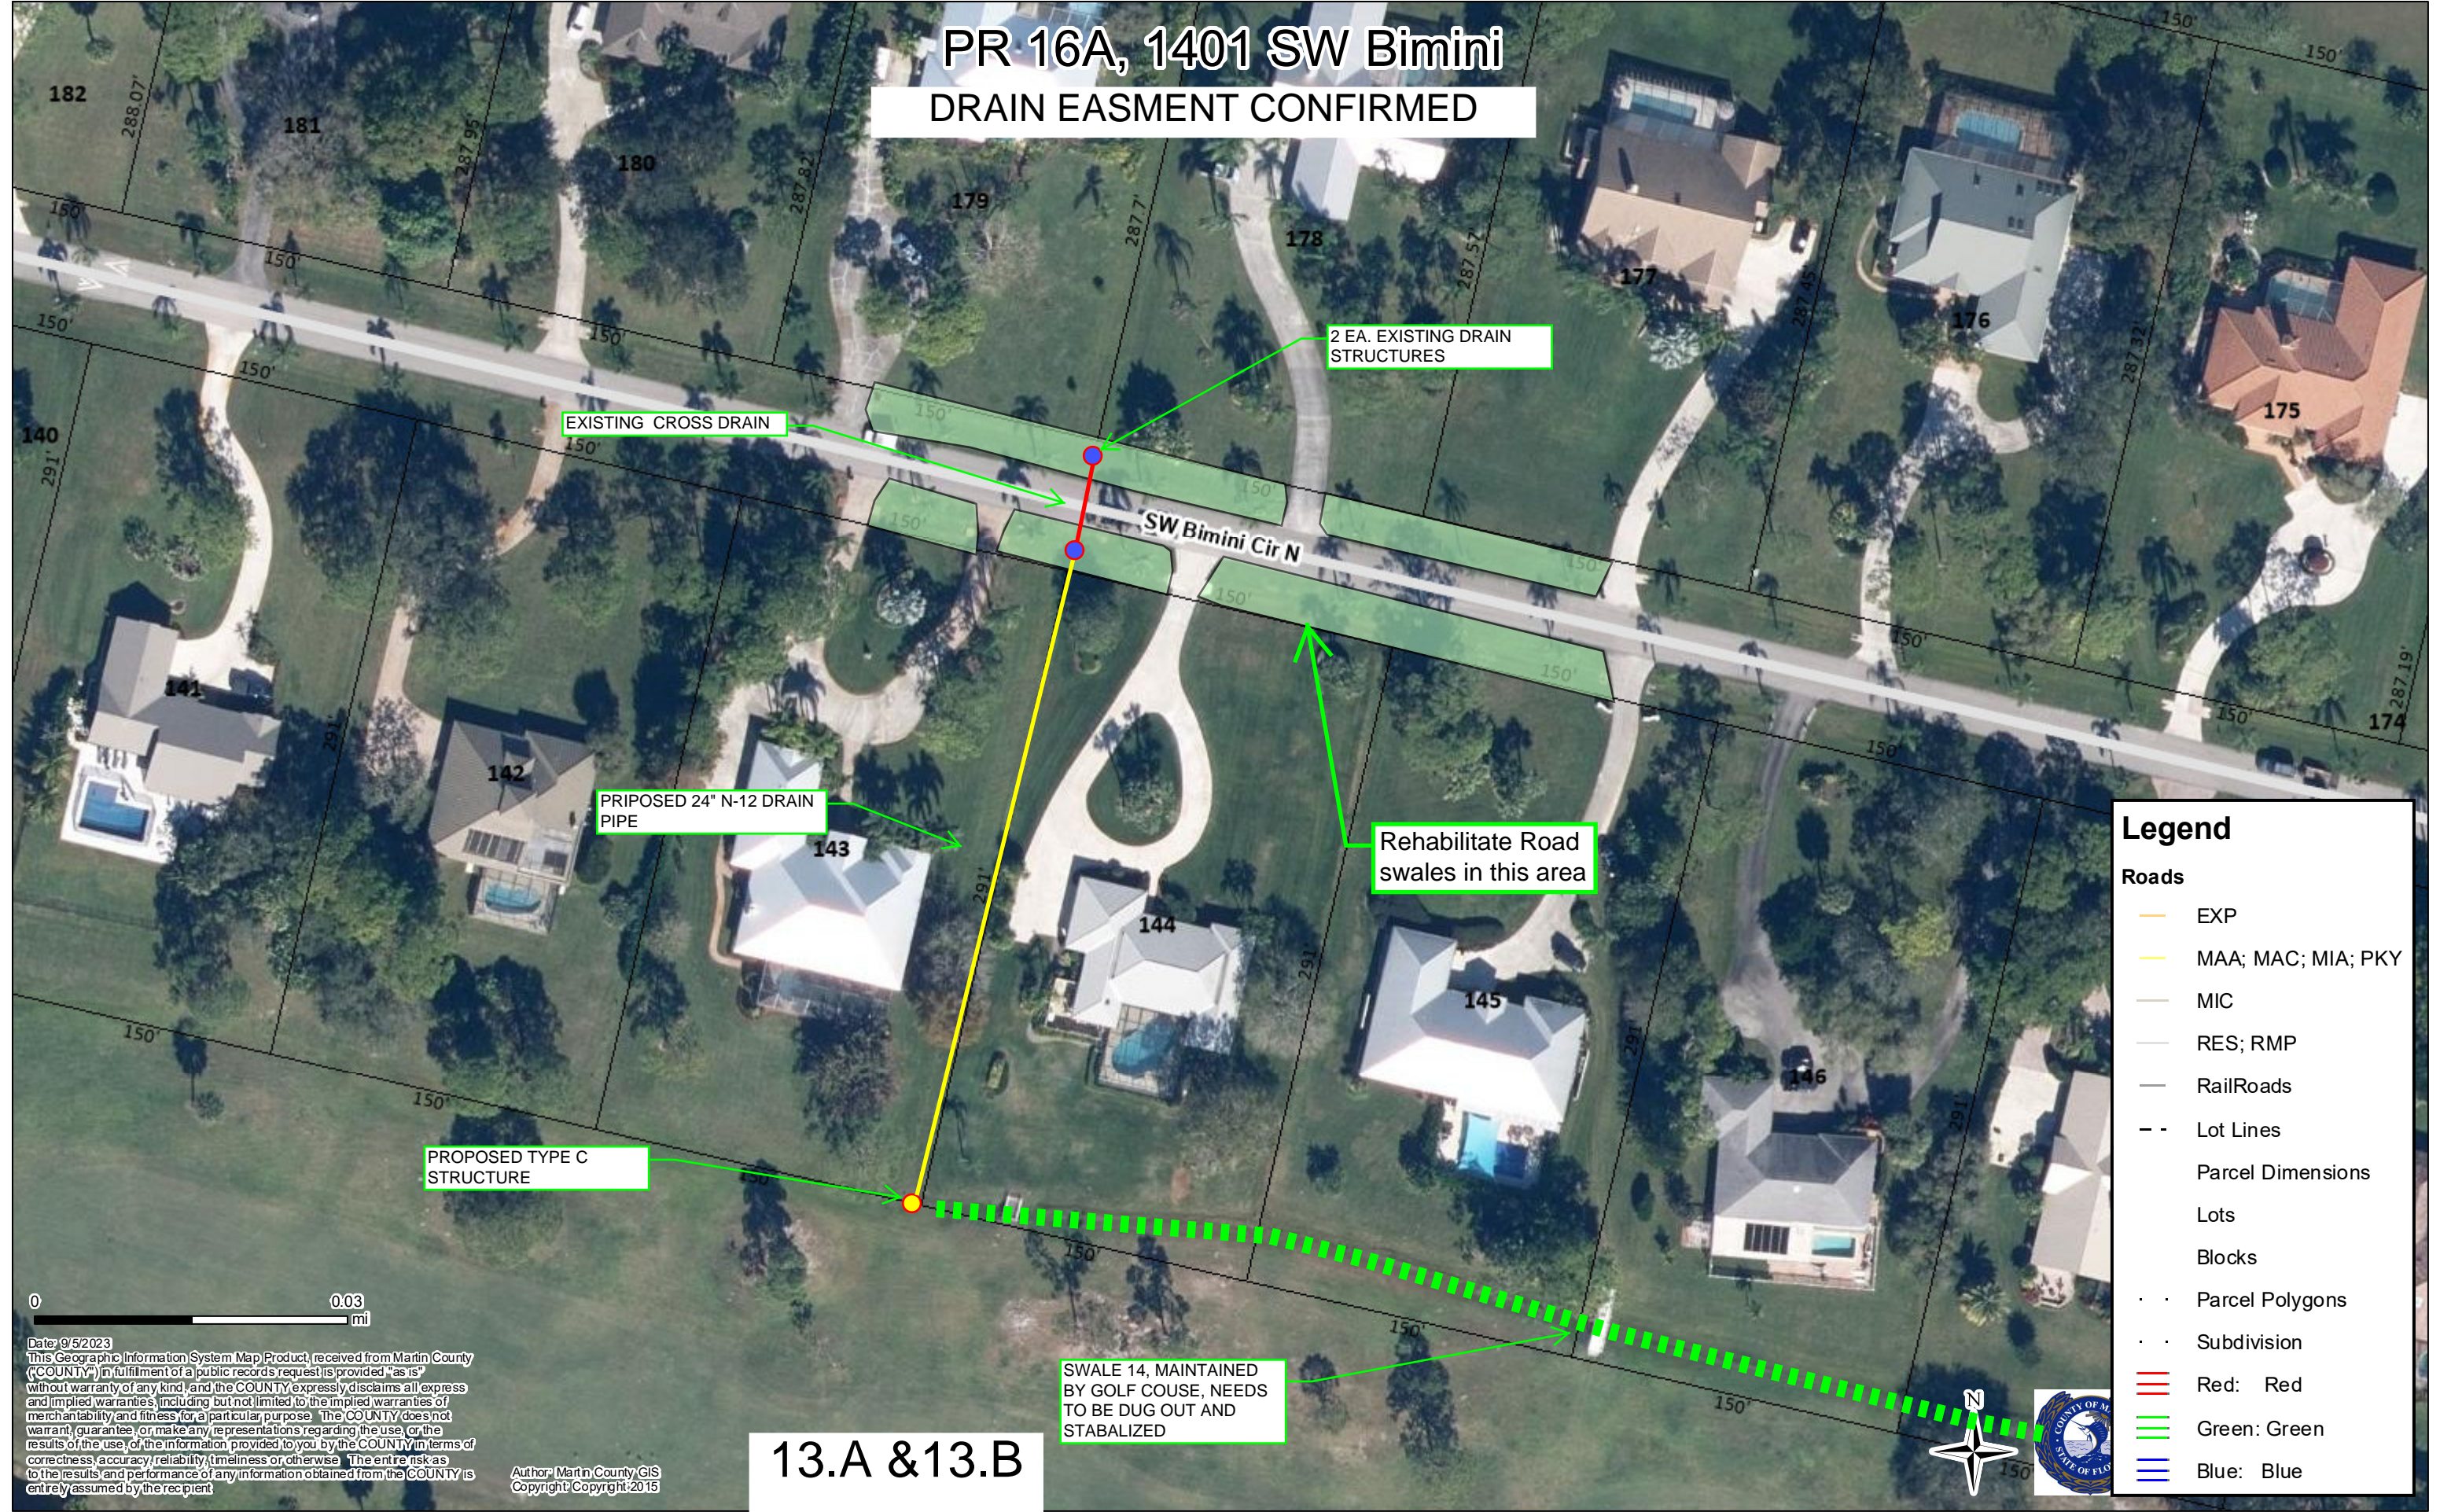
PR 16A, 1401 SW Bimini DRAIN EASMENT CONFIRMED

EXISTING CROSS DRAIN

2 EA. EXISTING DRAIN STRUCTURES

SWALE 14, MAINTAINED BY GOLF COUSE, NEEDS TO BE DUG OUT AND STABILIZED

PROPOSED 24" N-12 DRAIN PIPE

Rehabilitate Road swales in this area

PROPOSED TYPE C STRUCTURE

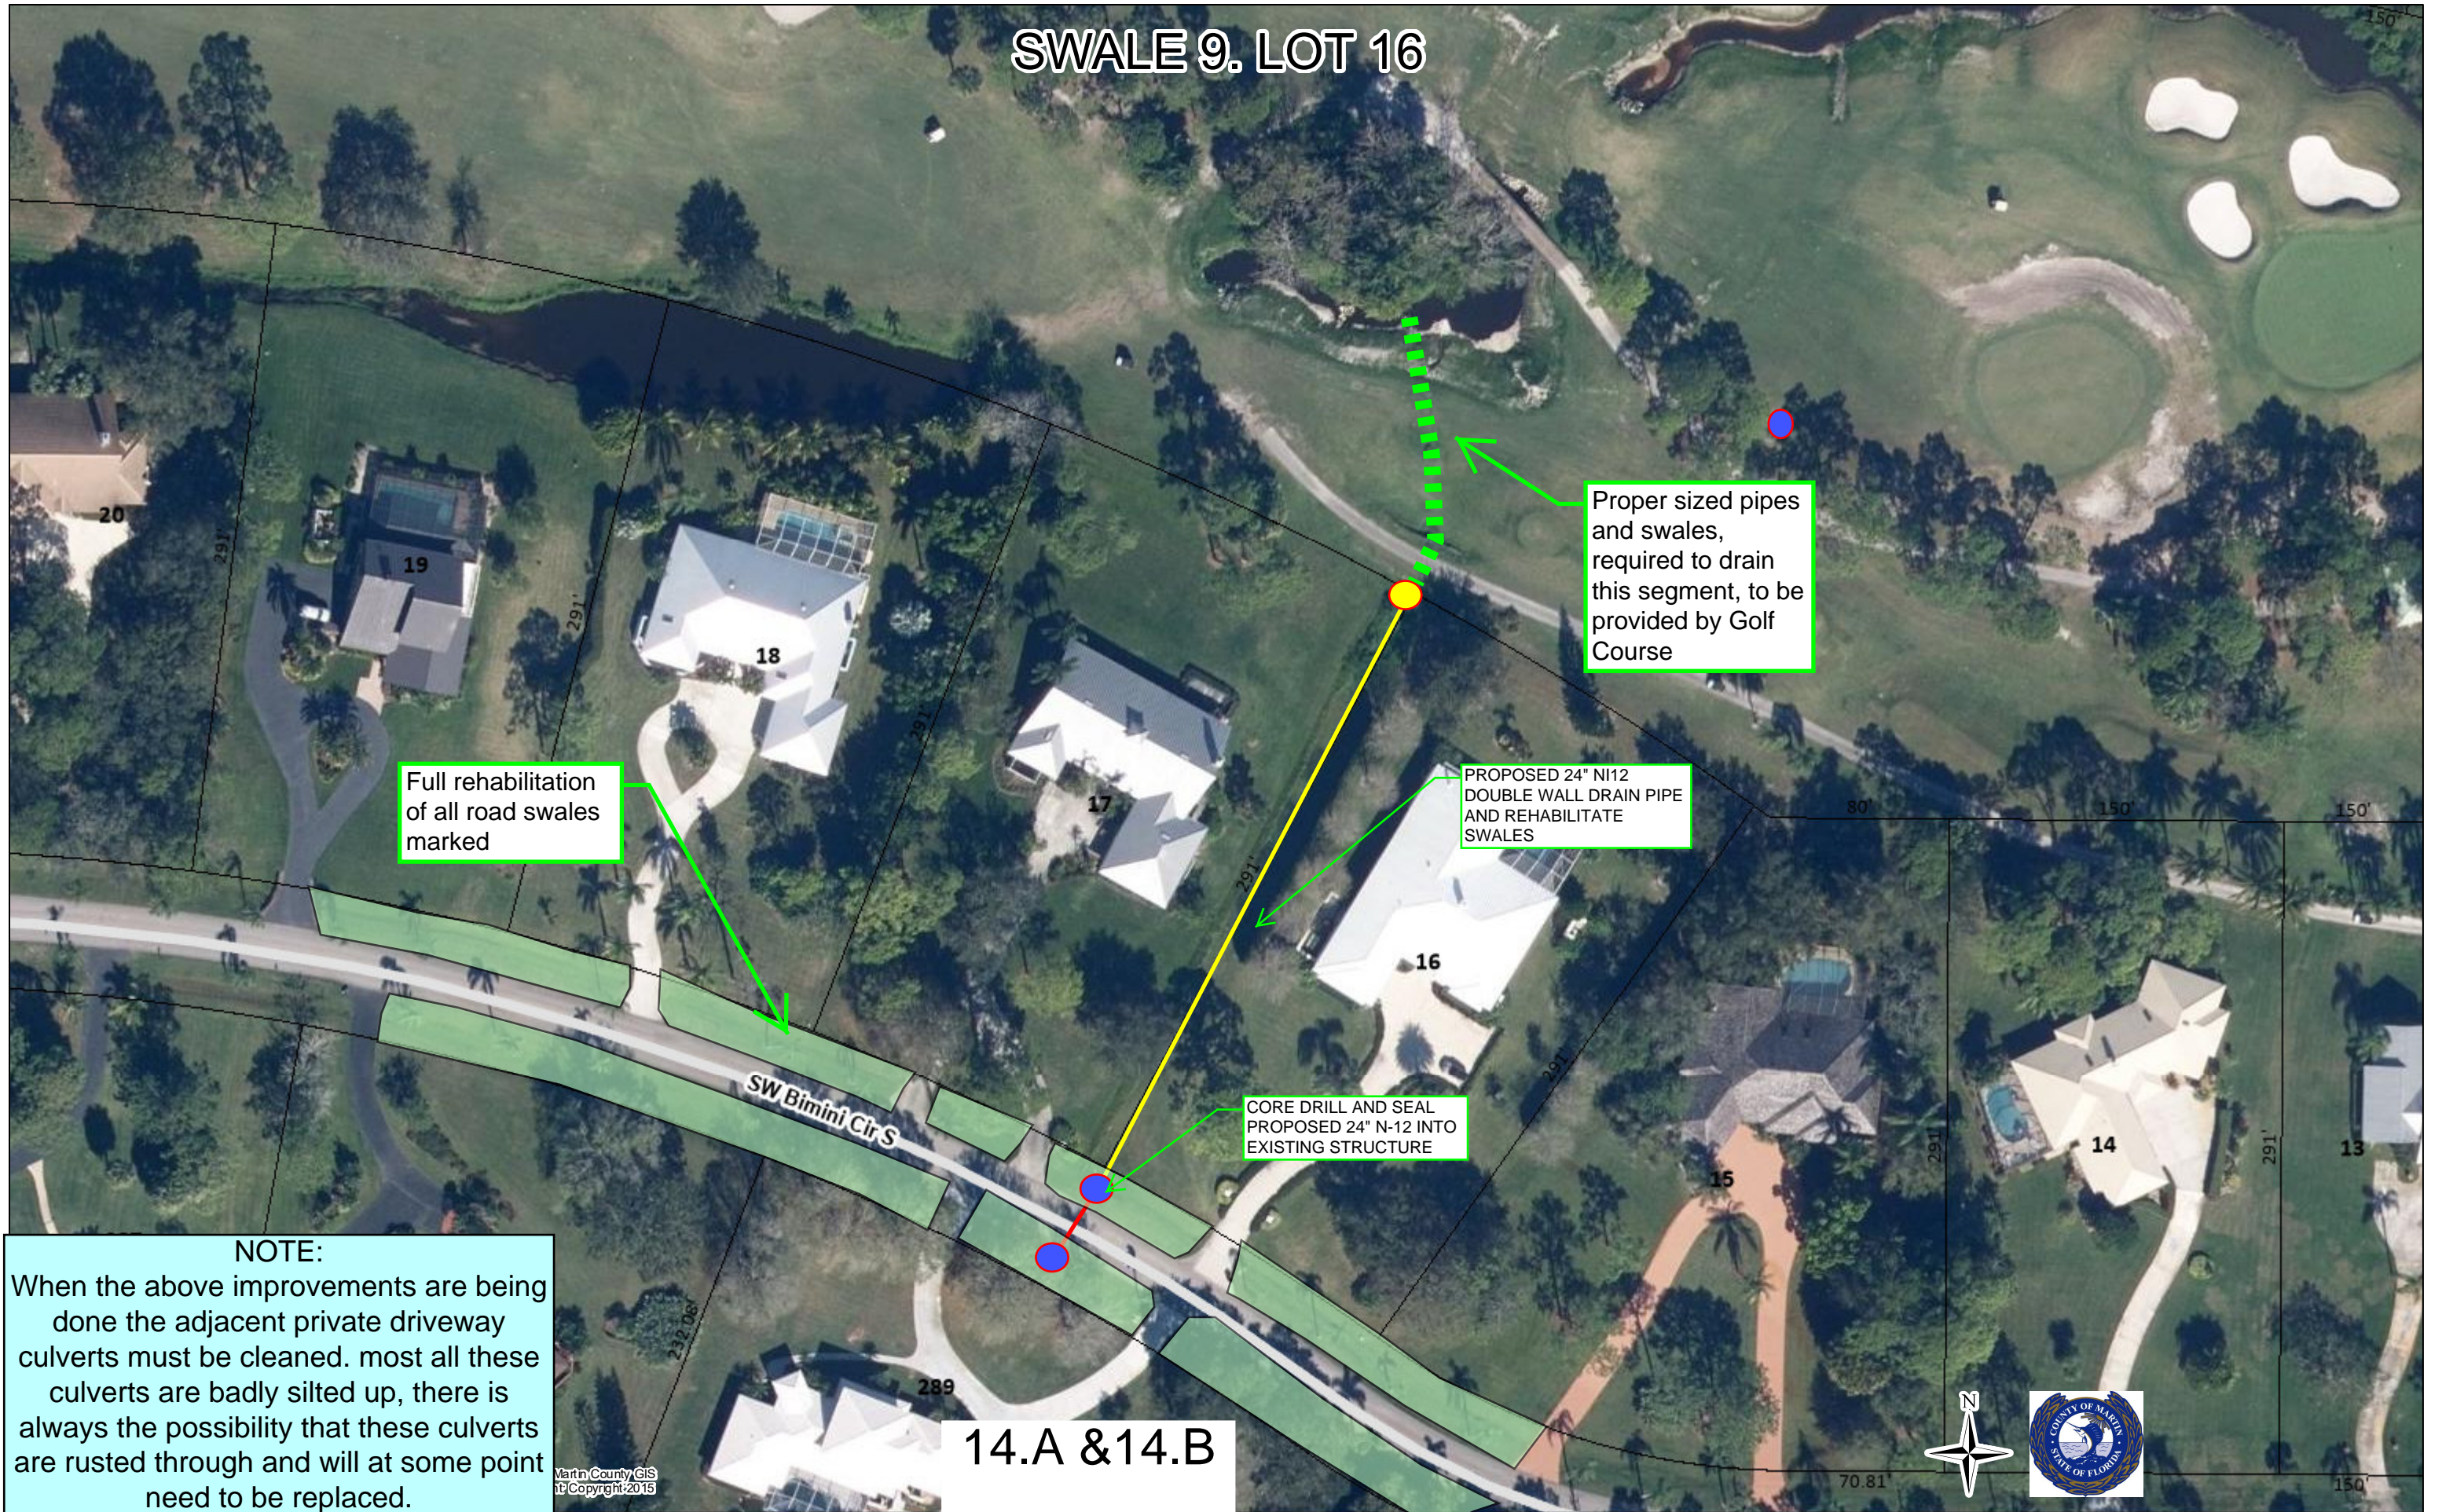
SWALE 9, LOT 16

Proper sized pipes and swales, required to drain this segment, to be provided by Golf Course

Full rehabilitation of all road swales marked

PROPOSED 24" N12 DOUBLE WALL DRAIN PIPE AND REHABILITATE SWALES

CORE DRILL AND SEAL PROPOSED 24" N-12 INTO EXISTING STRUCTURE

NOTE:
When the above improvements are being done the adjacent private driveway culverts must be cleaned. most all these culverts are badly silted up, there is always the possibility that these culverts are rusted through and will at some point need to be replaced.
